HMMWV...

OIL COOLER FAILURE DEAD-LINES TRUCK!

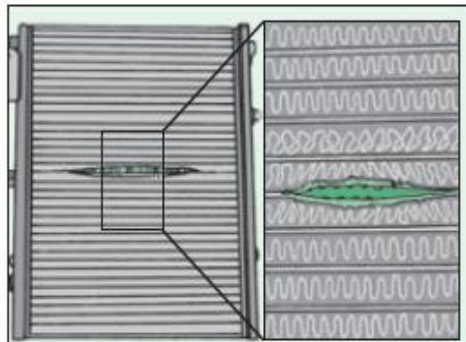
These tubes could expand or rupture during initial engine warm-up or start-up, especially when the vehicle's hydraulic system is cold. A ruptured power steering cooler causes a loss of power steering fluid and pressure, making your HMMWV hard to steer. Braking will also suffer because the power hydroboost is also affected. You don't need hard steering or braking, especially in a war zone!

Failure example: Ruptured power steering flow tube

Avoid this by inspecting the combination oil cooler for ruptures, leaks or swollen tubes like the PMCS table in TM 9-2320-387-10 says. Here's a quick reminder, as it relates to the oil cooler:

If you find a faulty oil cooler, your HMMWV is NMC! And it'll stay that way until the combination oil cooler is replaced. By the way, an oil cooler relief valve retrofit kit has been developed to prevent premature failure of the combination oil cooler. But your HMMWV isn't NMC if this retrofit kit is not installed.
